## **PRE-EXPORT VEHICLE INSPECTION STANDARDS**

## 輸出前車両検査基準

## EXAMPLES OF VEHICLE FIRST INSPECTION FAILURE (車両初回検査の不合格例)

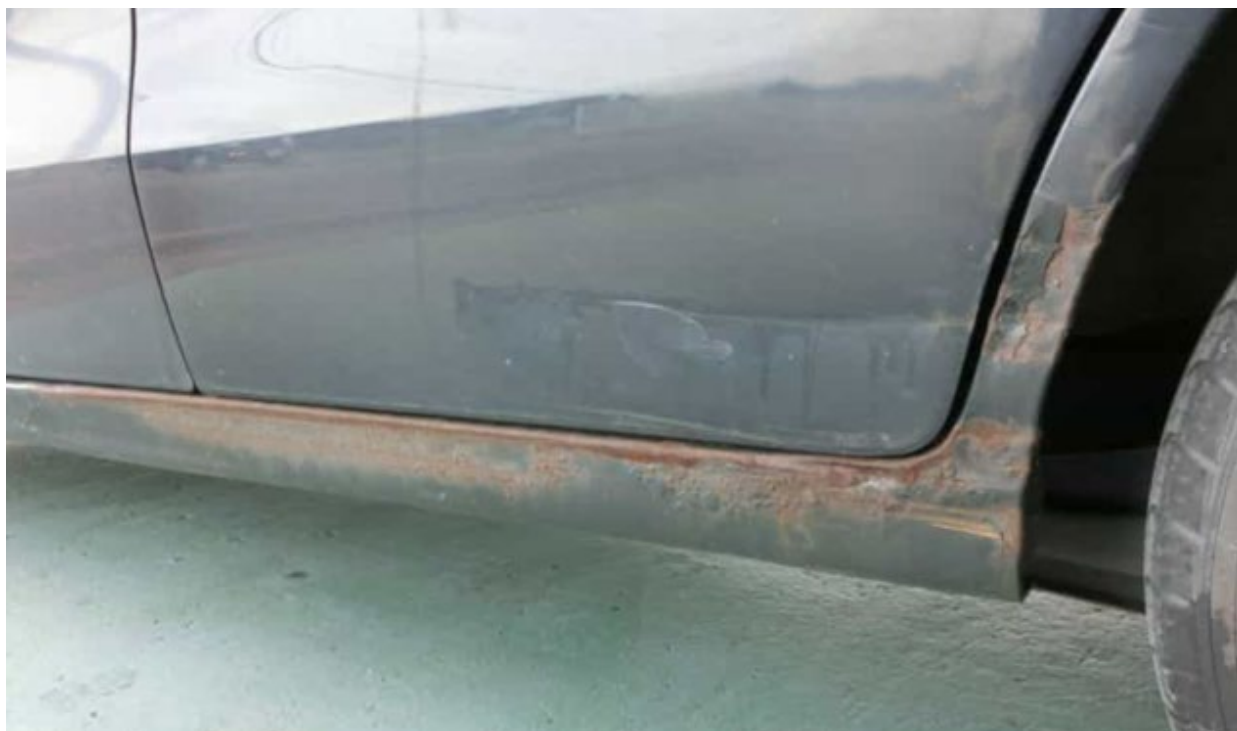
写真 1 (Corrosion or sill damage - サイドシルとホイールアーチ部の錆・腐食)

- ✓ 錆がない(もしくは錆止めのペイントが施されている)こと
- ✓ 外観を損ねる補修がされていないこと(ガムテープ補修、シリコン補修などは不可)
- ✓ 外装パネルに凹み・亀裂・穴などのダメージがないこと  
※ドア等の開閉がスムーズにできない場合は不合格  
※写真 1.2.参照
- ✓ 突起物(ダメージ部のめくれ、突出、折れたアンテナ、破損した部品の断面なども含む)がないこと
- ✓ 部品の欠損がないこと(バンパー等の割れ、欠けなど)  
※写真 3.4 参照
- ✓ 部品のガタツキがないこと(バンパー等の外れ)  
※写真 5 参照

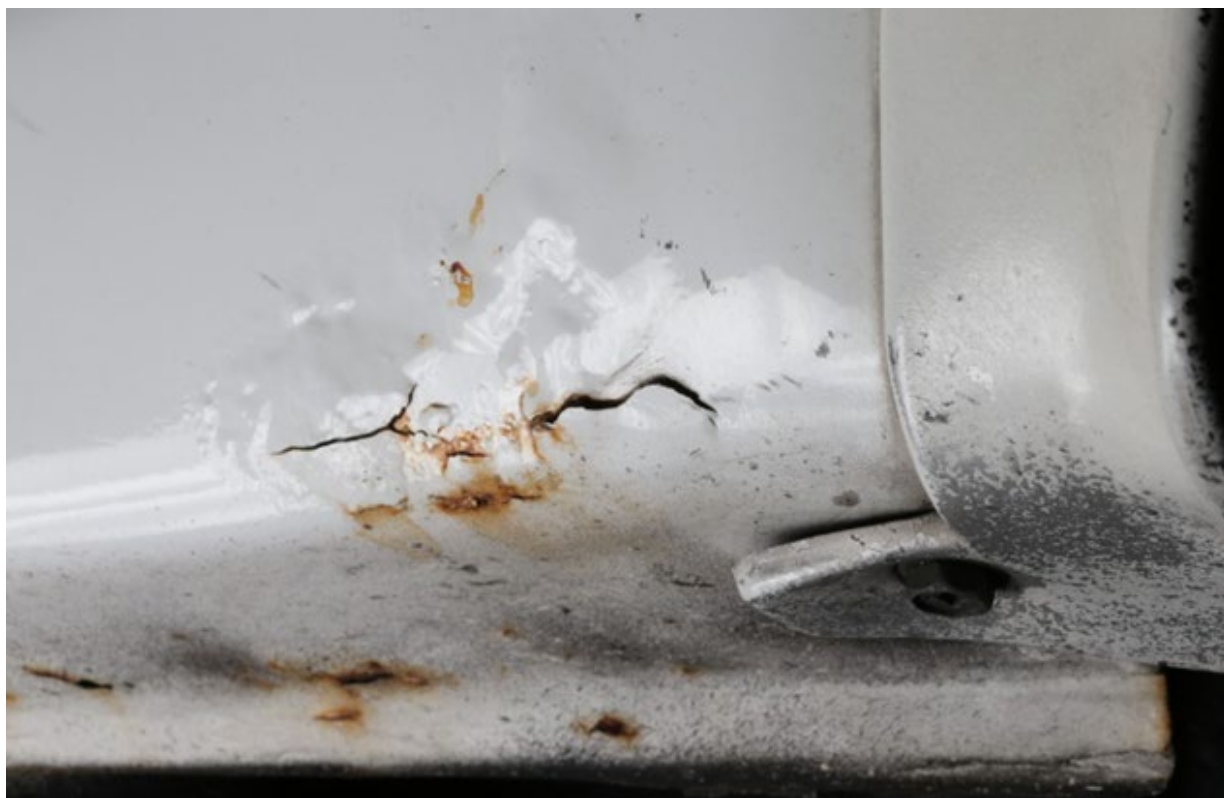
写真 2 Quarter panel hole/rust クォーターパネルの穴・錆

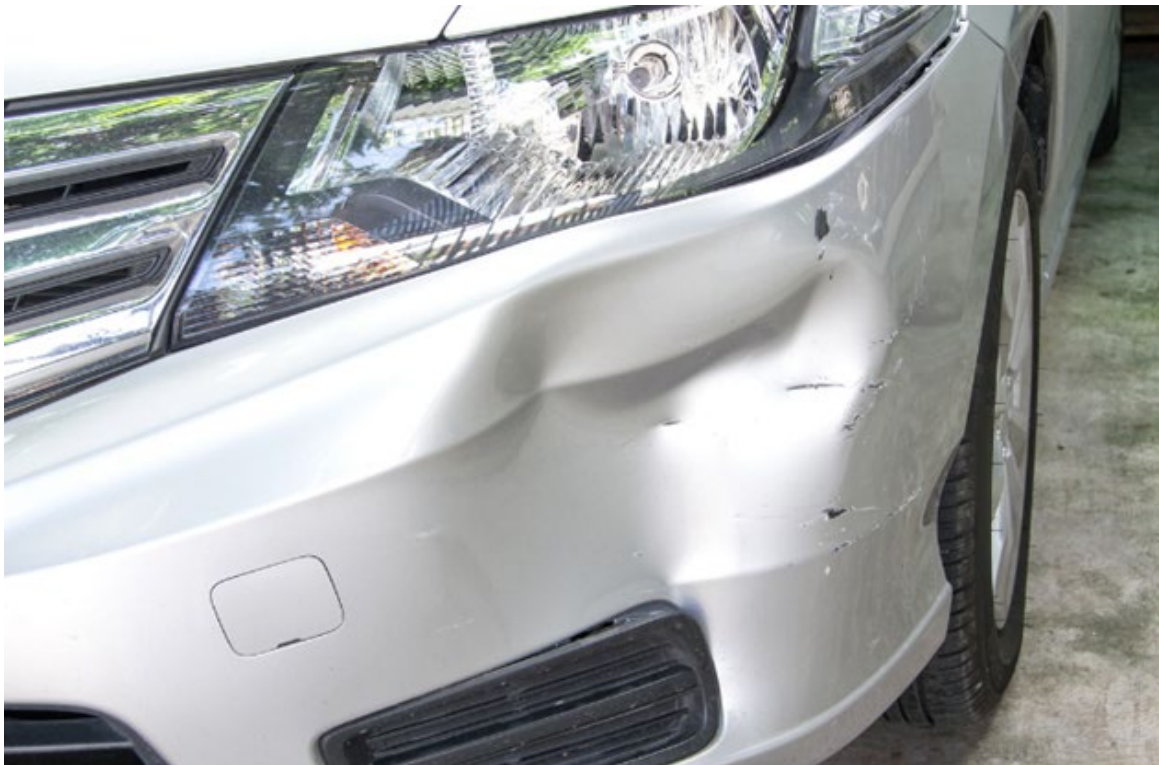
写真 3 Bumper damage バンパーの凹み

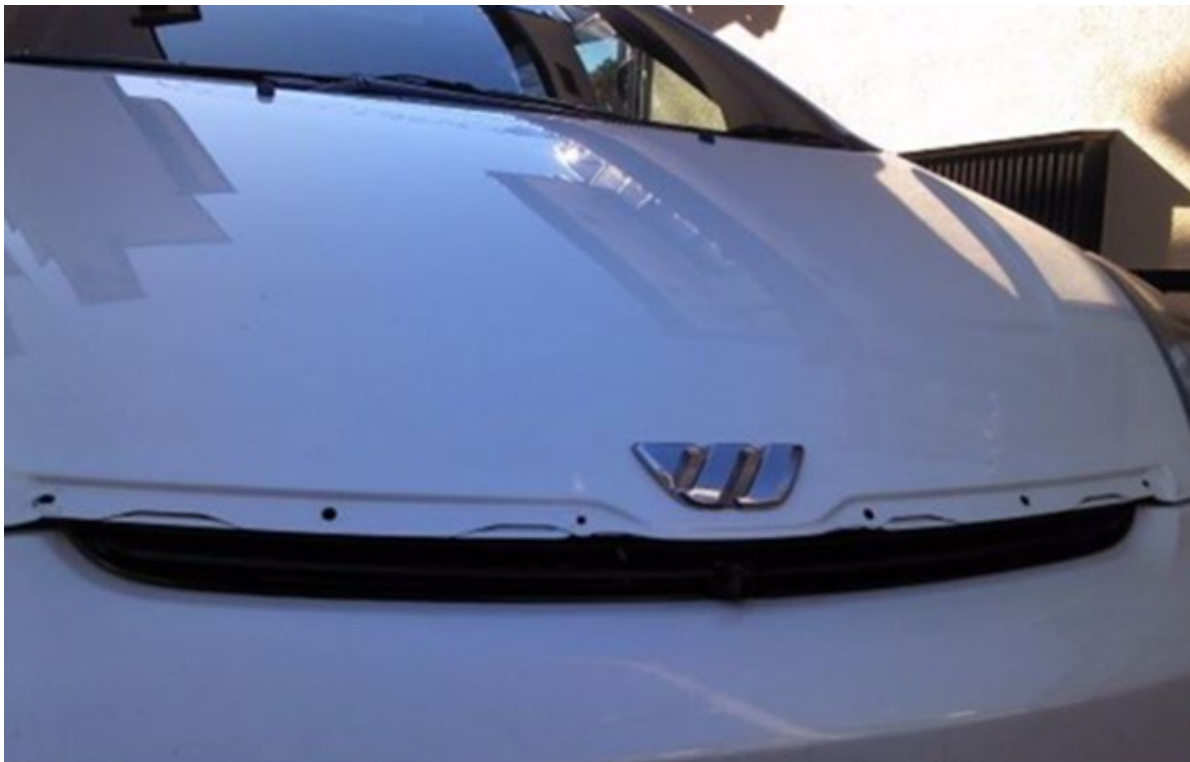
写真 4 Missing bonnet parts ボンネットエンド部品の欠損

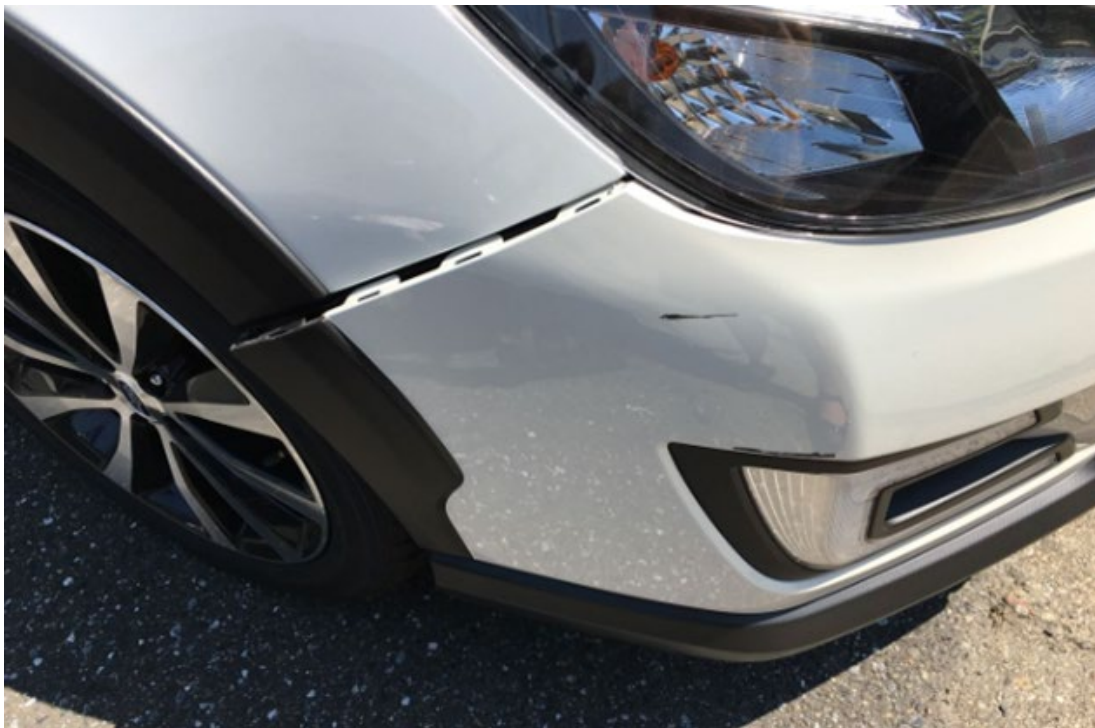
写真5 Bumper detached バンパーの外れ

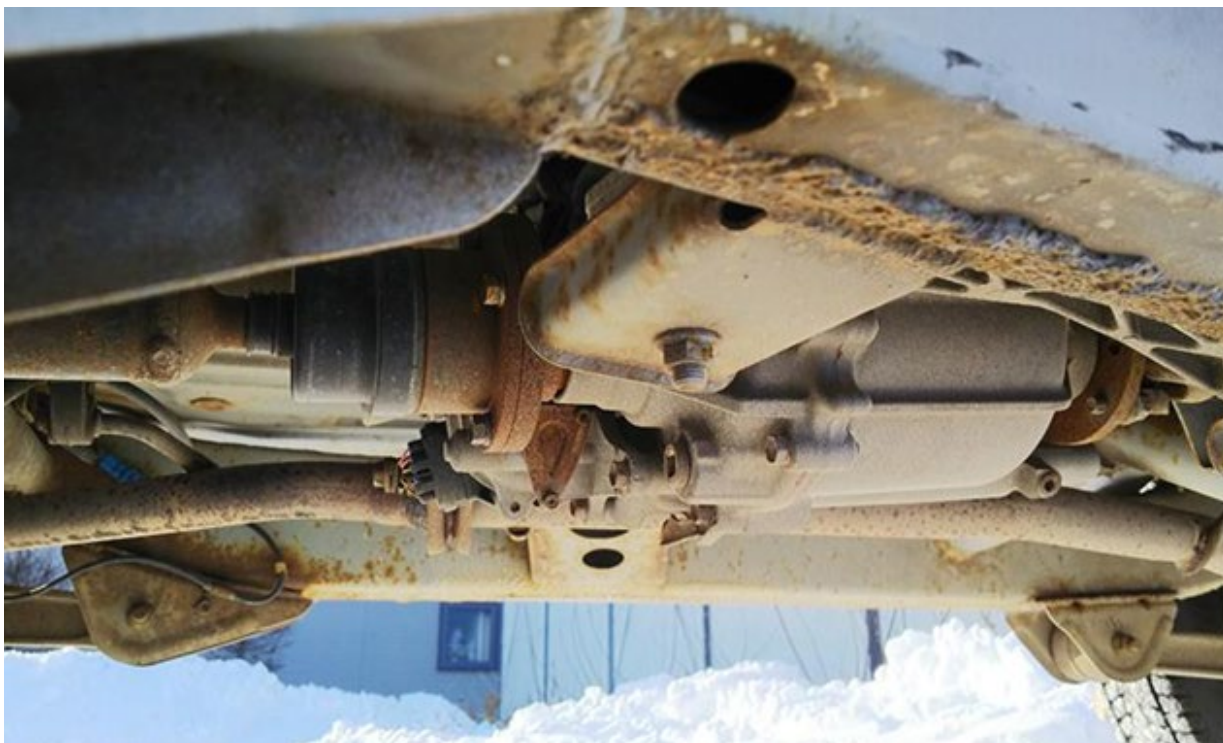
写真6 Chassis rust/corrosion シャシーの錆

- ✓ 錆がない(もしくは錆止めのペイントが施されている)こと
  - ※ 例えば、ディファレンシャルケースの切断面のように、製造時に錆止めのペイントが施されていない部分に経年劣化により発生した錆は除く
  - ※ 写真 6.7.8 参照
- ✓ 水、オイル、燃料等の漏れがないこと
- ✓ ブーツ、ブッシュ類に破れがないこと
- ✓ 各取り付け部にガタ、緩みがないこと  
(各足回り、タイロッド、ドライブシャフト、マフラー吊下げ部、駐車ブレーキワイヤーなど)
  - ※ マフラーの針金固定は不可
- ✓ 緩衝装置は正常に機能していること

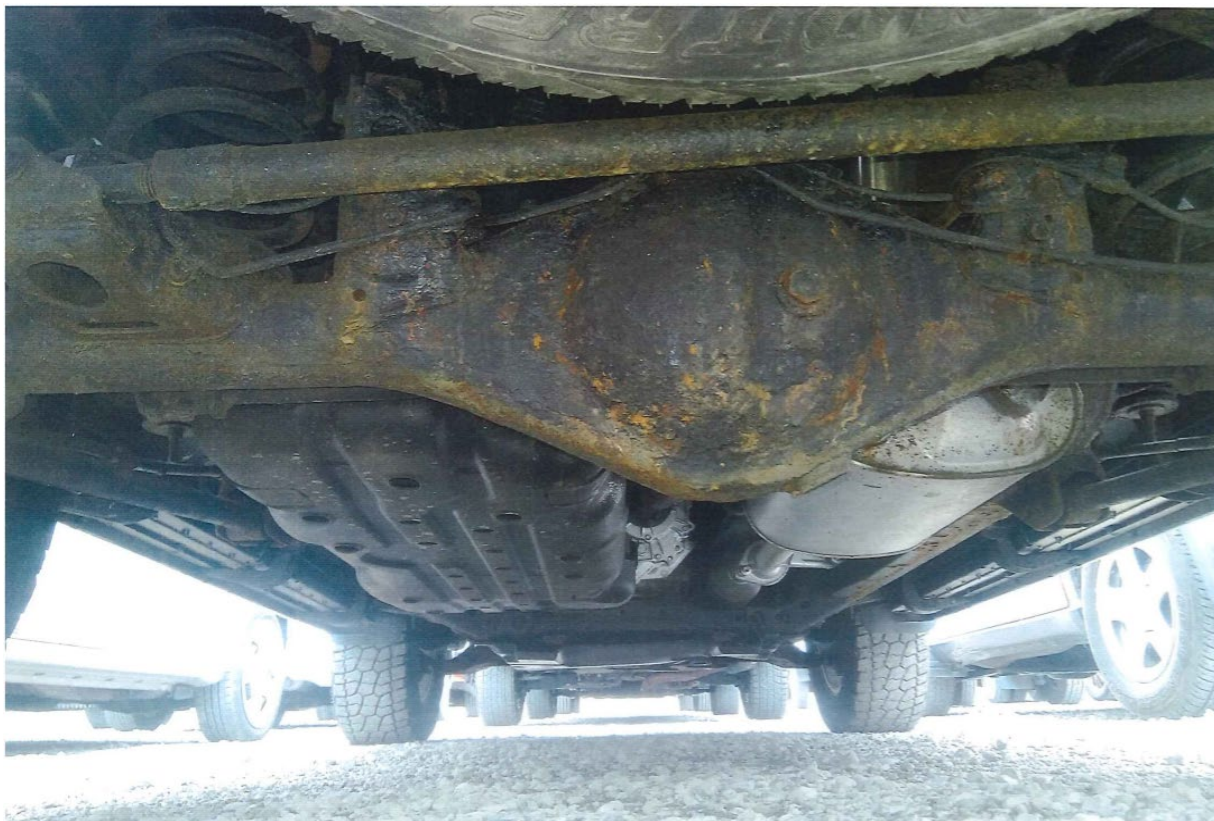
写真7 Rust on rear differential リアデファレンシャルの錆

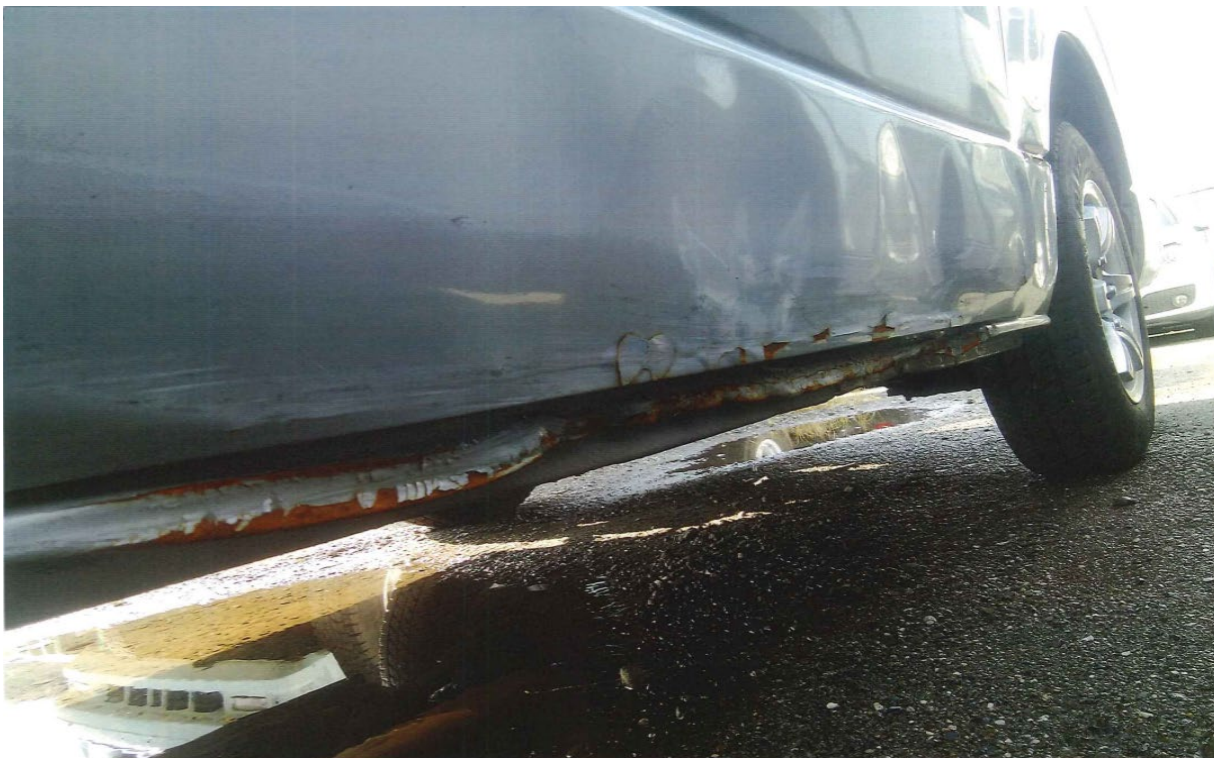
写真8 Rust/corrosion at the bottom of the side sill サイドシル下部の錆・腐食

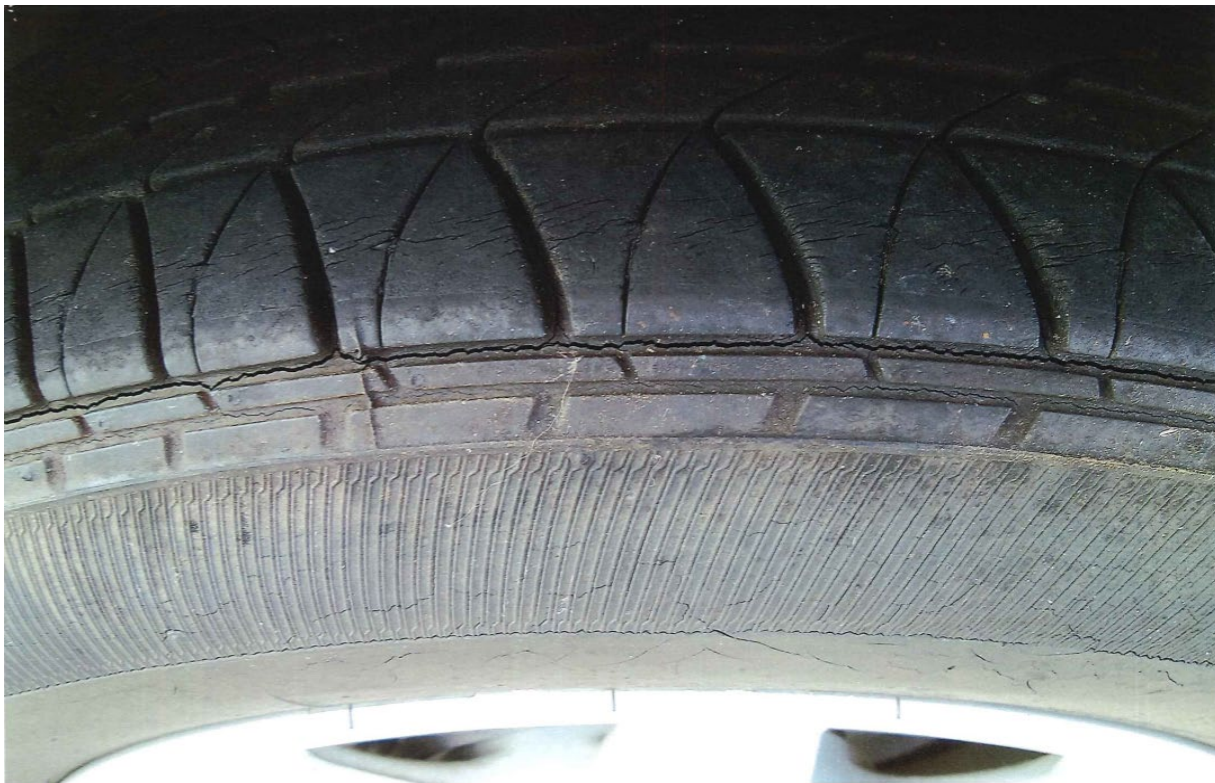
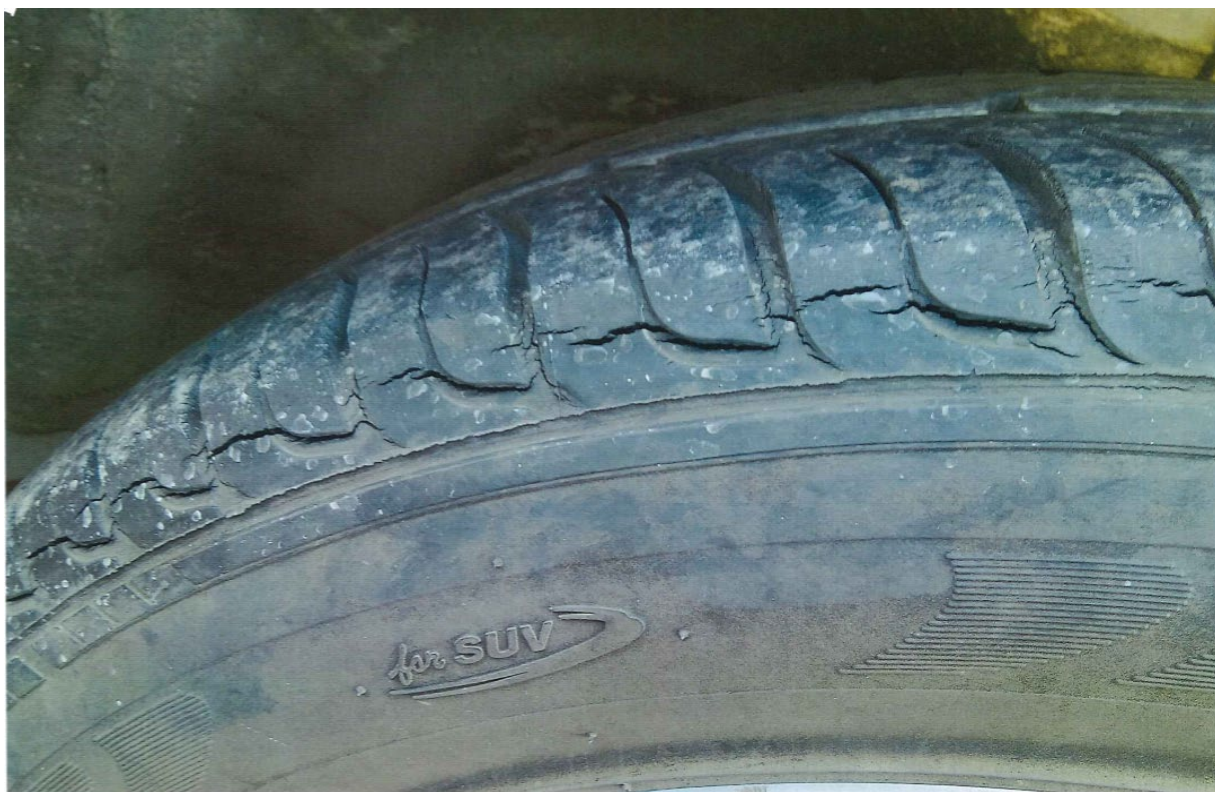
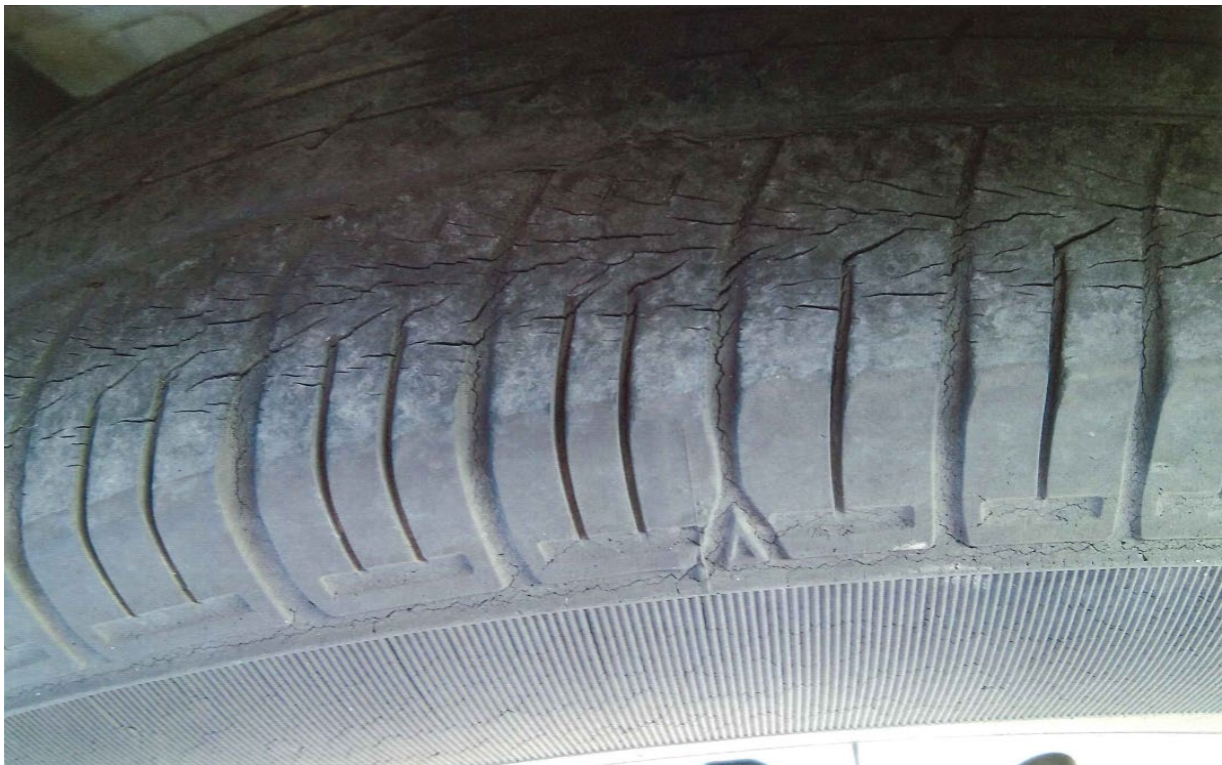
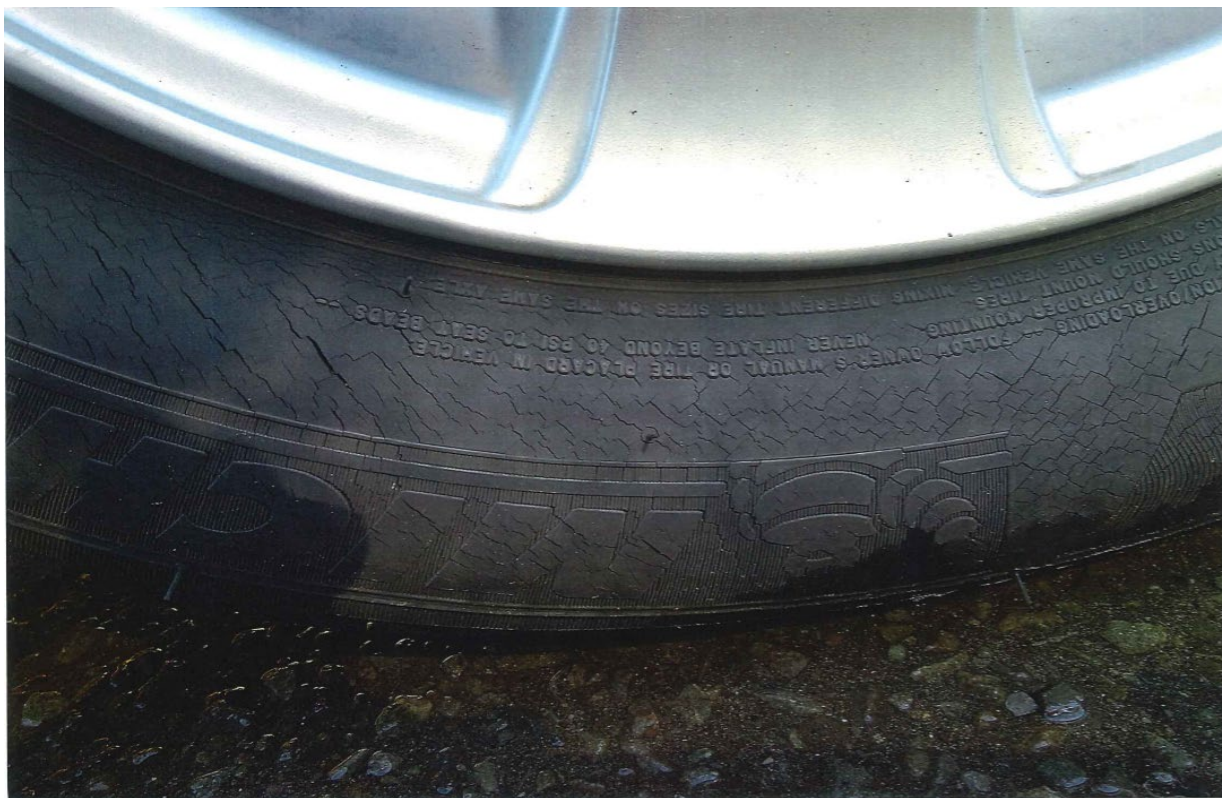
写真 9 Tire cracking タイヤの亀裂

写真 10 Tire cracking タイヤの亀裂

写真 11 Tire cracking タイヤの亀裂

写真 12 Tire cracking タイヤの亀裂

- ✓ 車両に合ったサイズであること
  - ※ はみ出し、ボディへの接触等不可
- ✓ 構造のどの部分にも、25mm 以上、もしくは接地面幅の 10%以上の亀裂、剥離、隆起などのダメージがないこと
  - ※ 表面の劣化による細かい亀裂を除く、亀裂の深さがワイヤーまで達している可能性があるものは不可
  - ※ 写真 9.10.11.12 参照
- ✓ 溝の深さは全て 1.6mm 以上であること (セントルシア向けは 4.0mm 以上であること)
  - ※ 片減りはトレッドパターンの 1/2 以上が確認できないものは不可(ワイヤーが出ているものも不可)
  - ※ 写真 13.14.15 参照
- ✓ しっかりと取り付けられていること(ハブナットの締結状態)
- ✓ 空気圧が規定値であること
  - ※ セントルシア向けはウインタータイヤ不可・タイヤ製造から 48 か月以内でなければならない

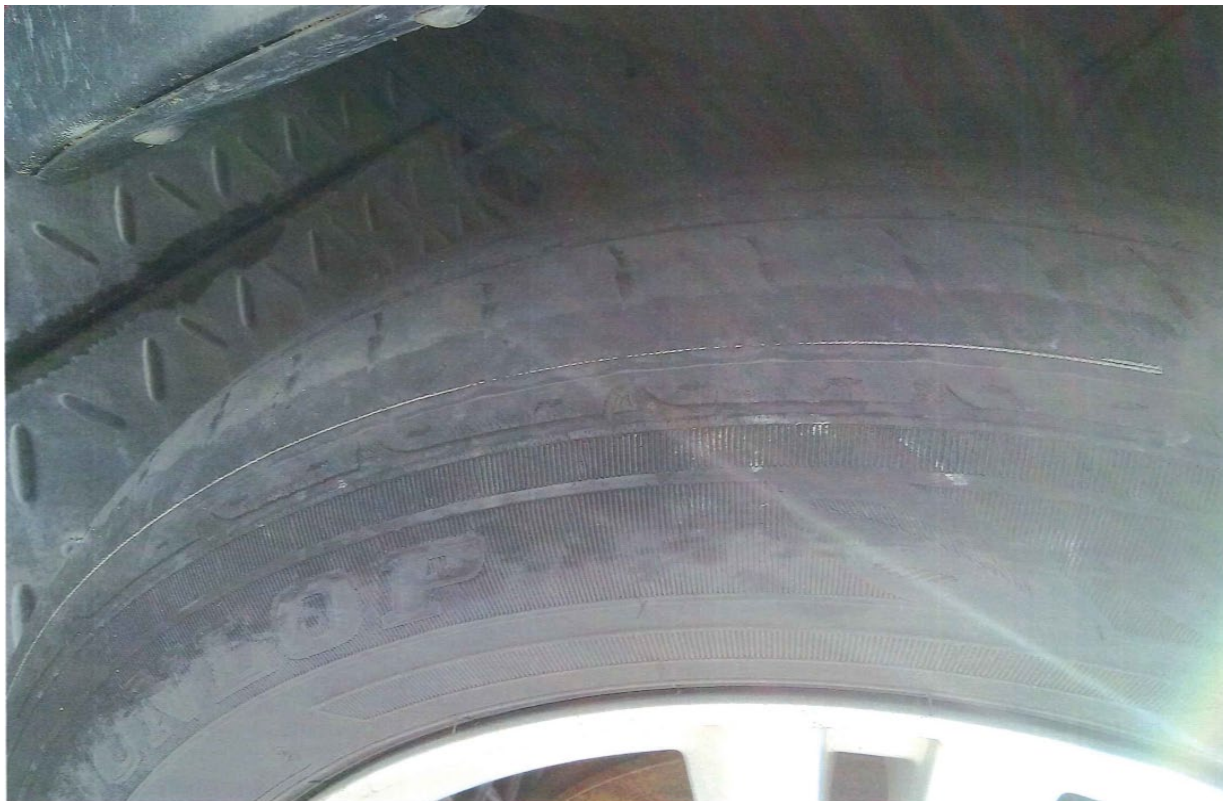
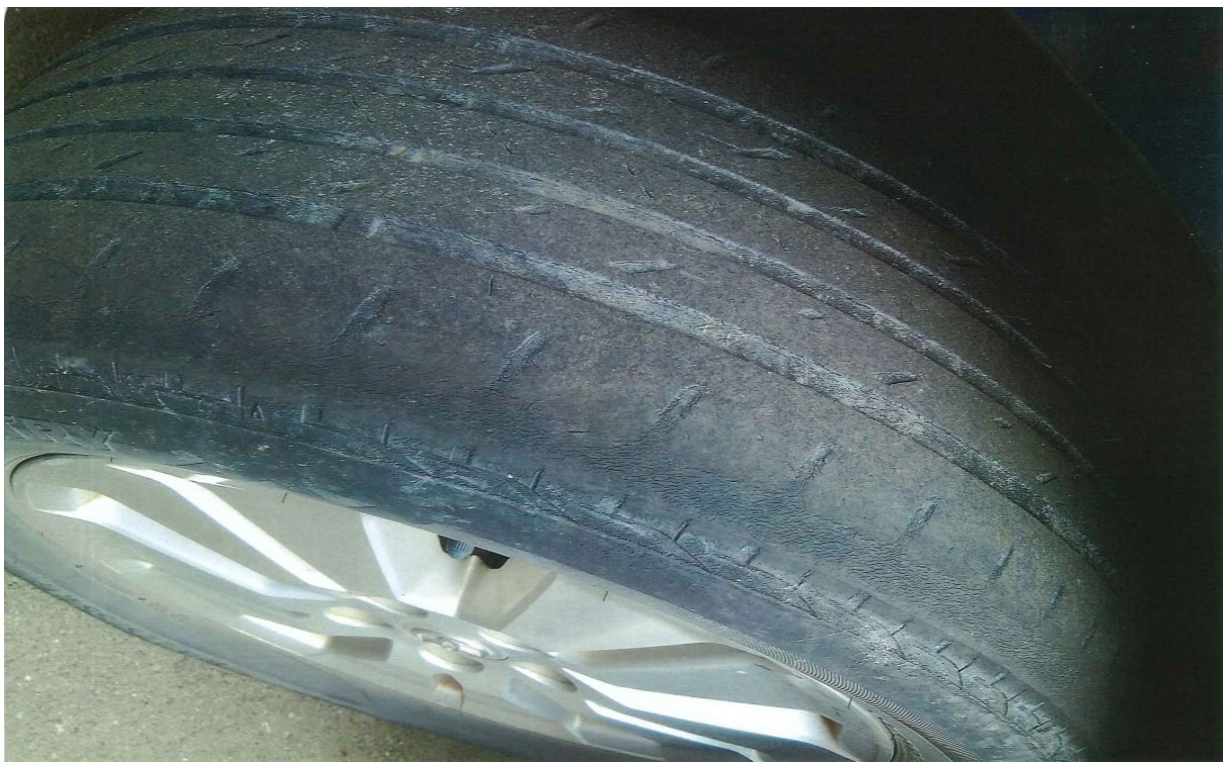
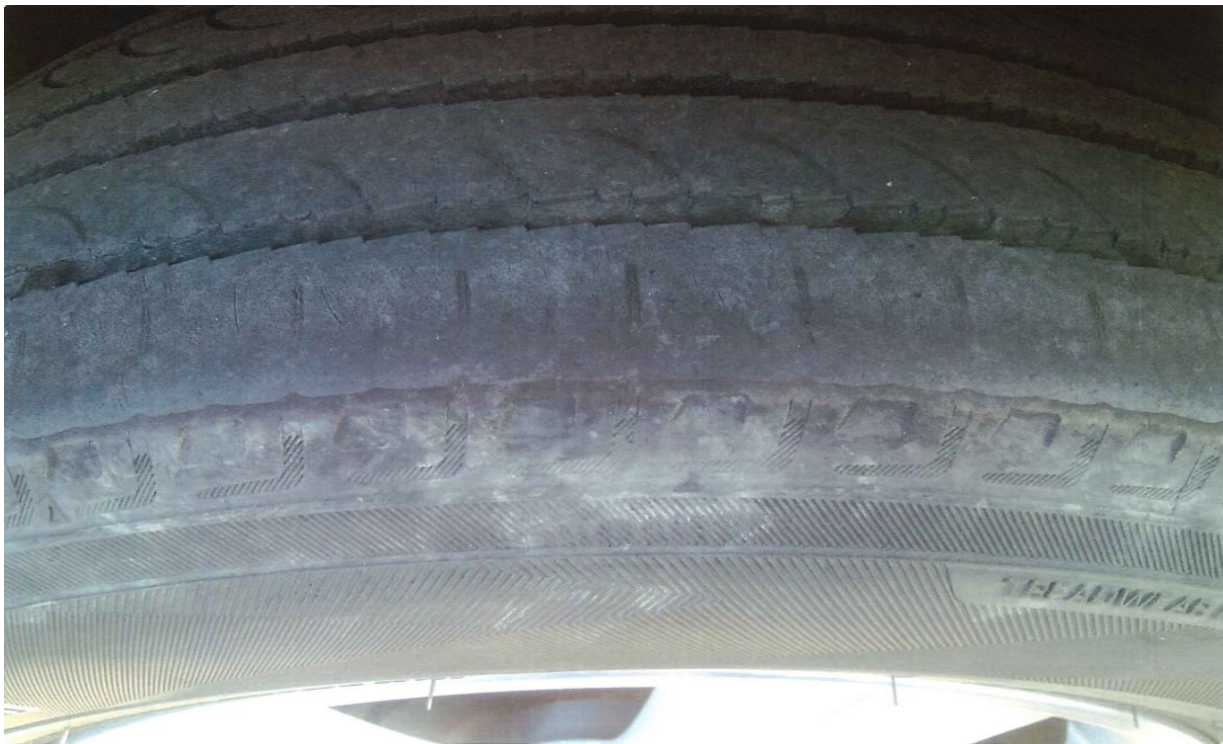
写真 13 Tire tread タイヤの方減り

写真 14 Tire tread タイヤの方減り

写真 15 Tire tread タイヤの方減り

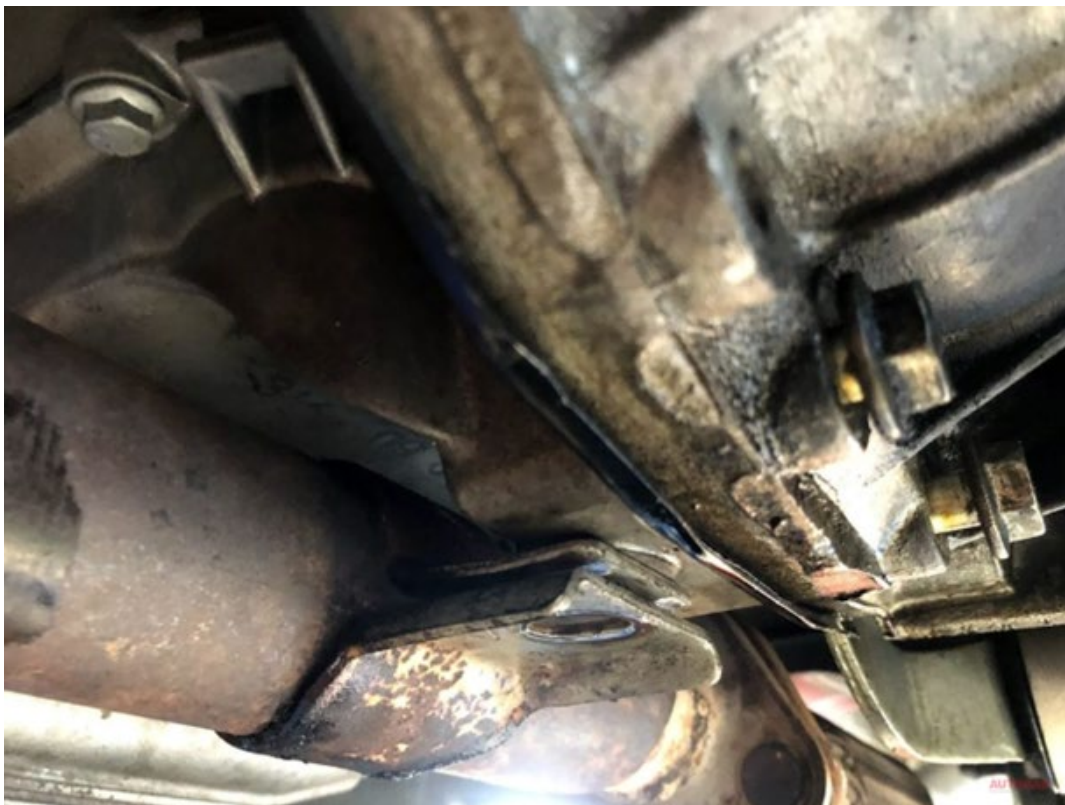
写真 16 Oil leak オイル漏れ

- ✓ 水、オイル、燃料等の漏れがなく、適量が入っていること
  - ※ エンジン下部への滴下、エキゾーストマニホールド等、加熱部品での白煙不可
  - ※ 写真 16 参照
- ✓ 著しく汚れていないこと
- ✓ 異音や振動がなく、正常に機能していること
- ✓ 錆がない(もしくは錆止めのペイントが施されている)こと

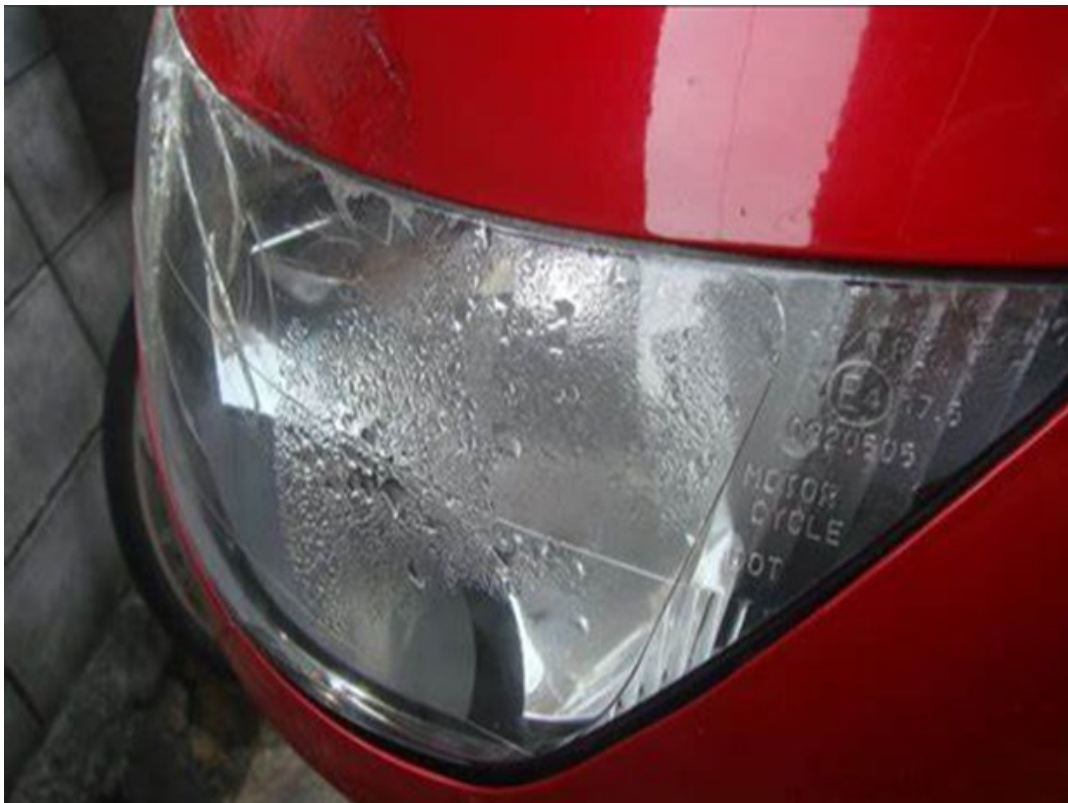
写真 17 Lens cracks or water inside the lens レンズの割れとレンズ内水たまり

- ✓ バルブ切れがないこと  
※ヘッドライトの左右色違いは不可
- ✓ スイッチやレバーなどの操作によって正常に点灯、または消灯すること
- ✓ レンズに割れなどのダメージがないこと  
※割れ、ひび等によるレンズ内の水たまりは不可
- ✓ レンズ表面等に塗料等が付着していないこと  
※写真 17.18 参照

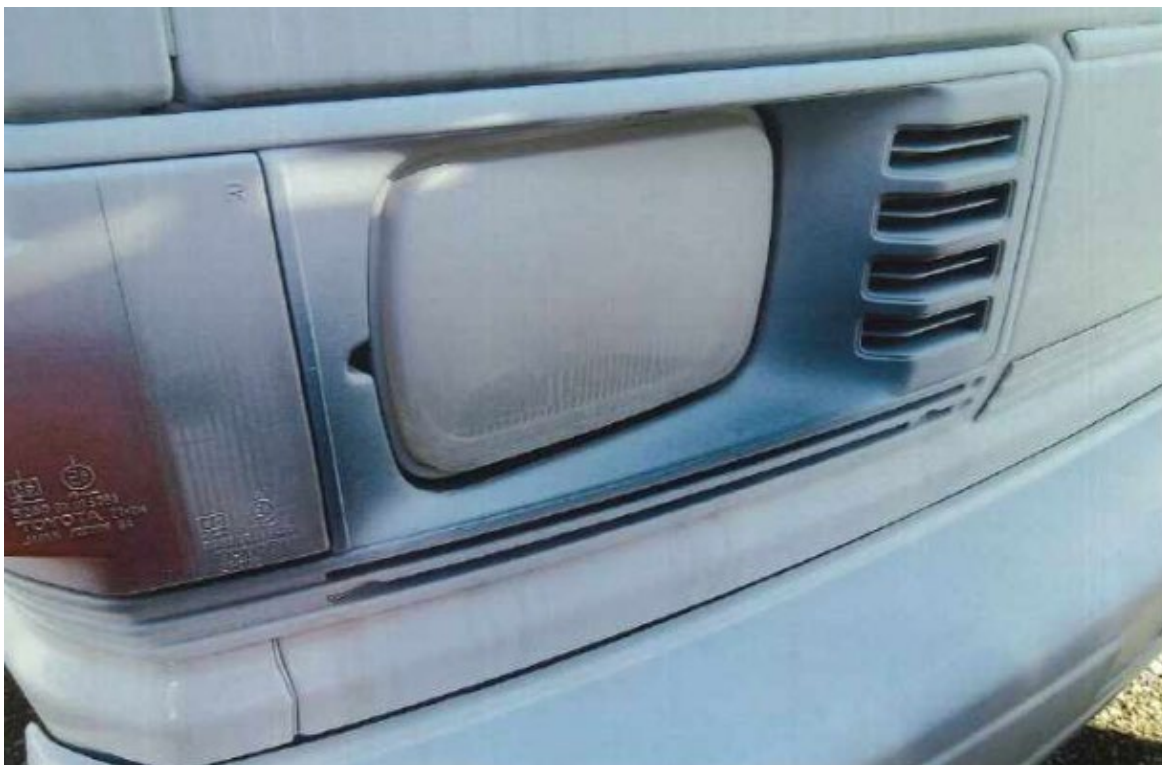
写真 18 Lens covered or not clear レンズに塗料付着

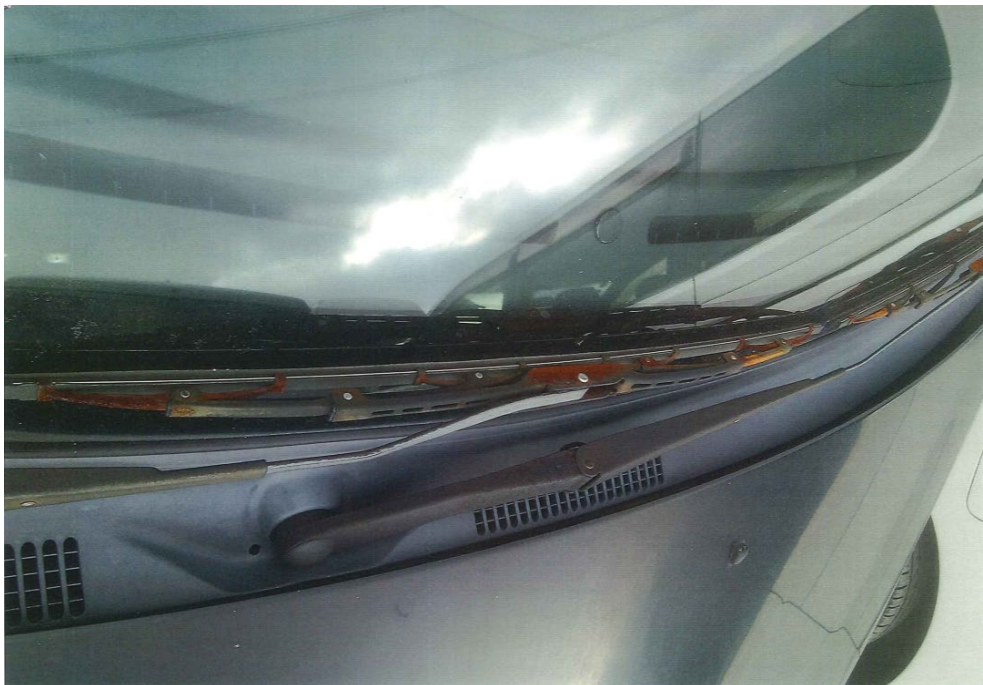
写真 19 Wiper arm rust ワイパーアームの錆

- ✓ スイッチ操作に応じた作動をすること
- ✓ 錆がない(もしくは錆止めのペイントが施されている)こと  
※アーム、ブレードの 1/2 以上の錆は不可  
※写真 19.20.21 参照
- ✓ 著しい拭き残しがないこと  
※ ゴム切れ不可

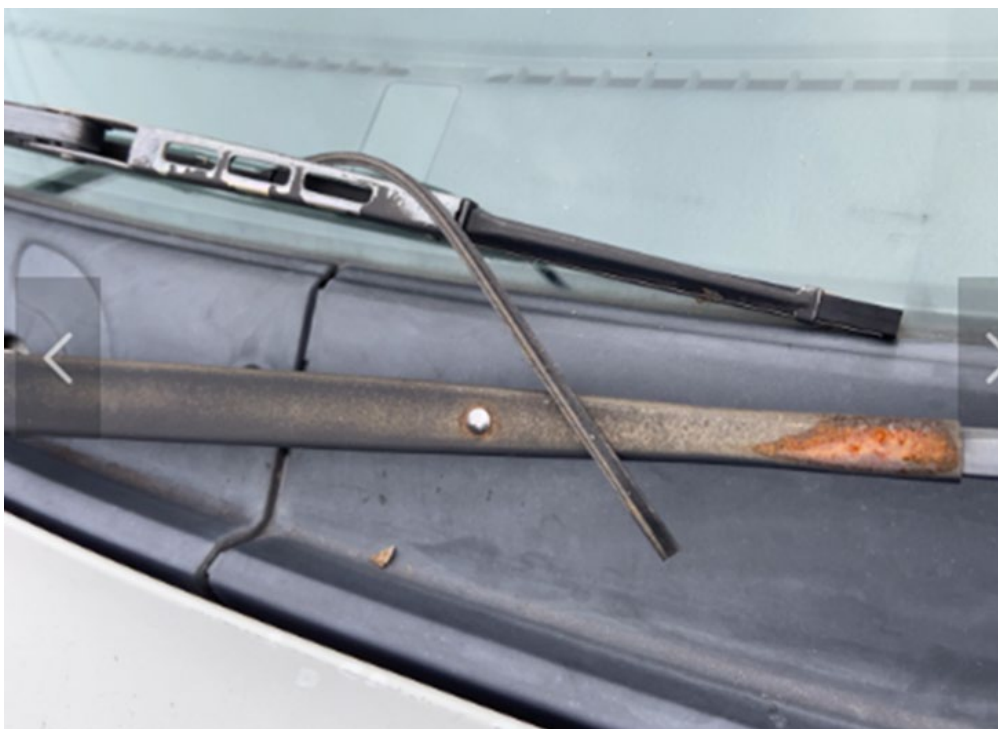
写真 20 Wiper rubber broken ワイパーゴム切れ

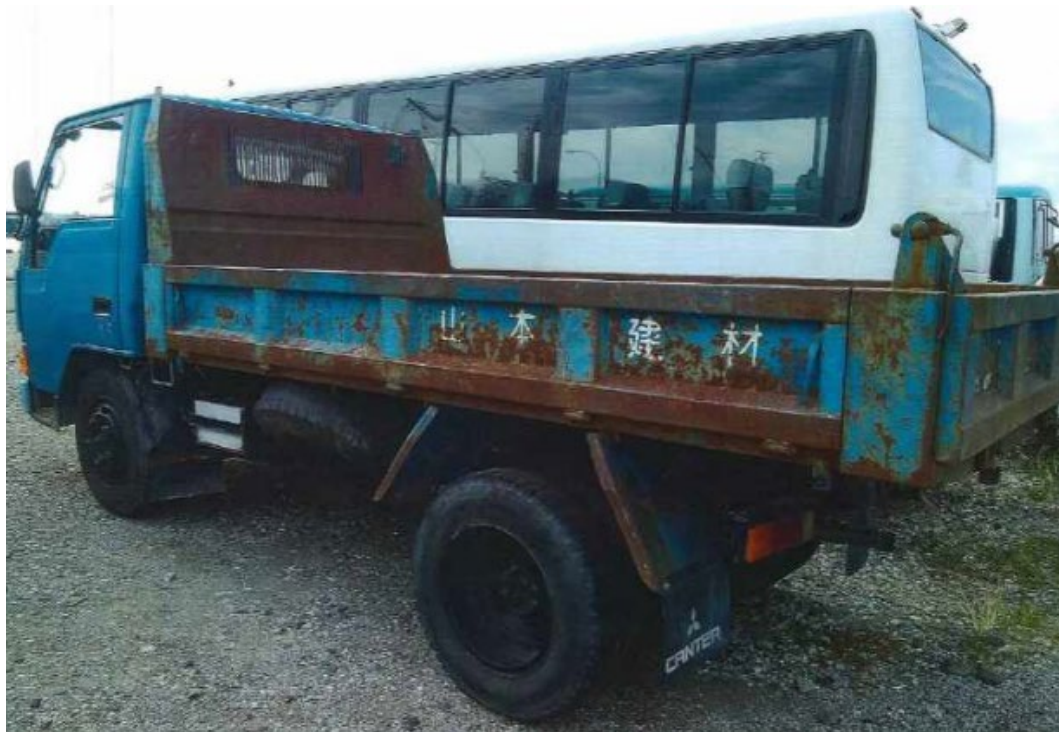
写真 21 Truck bed rusted/corroded トラック荷台の錆・腐食

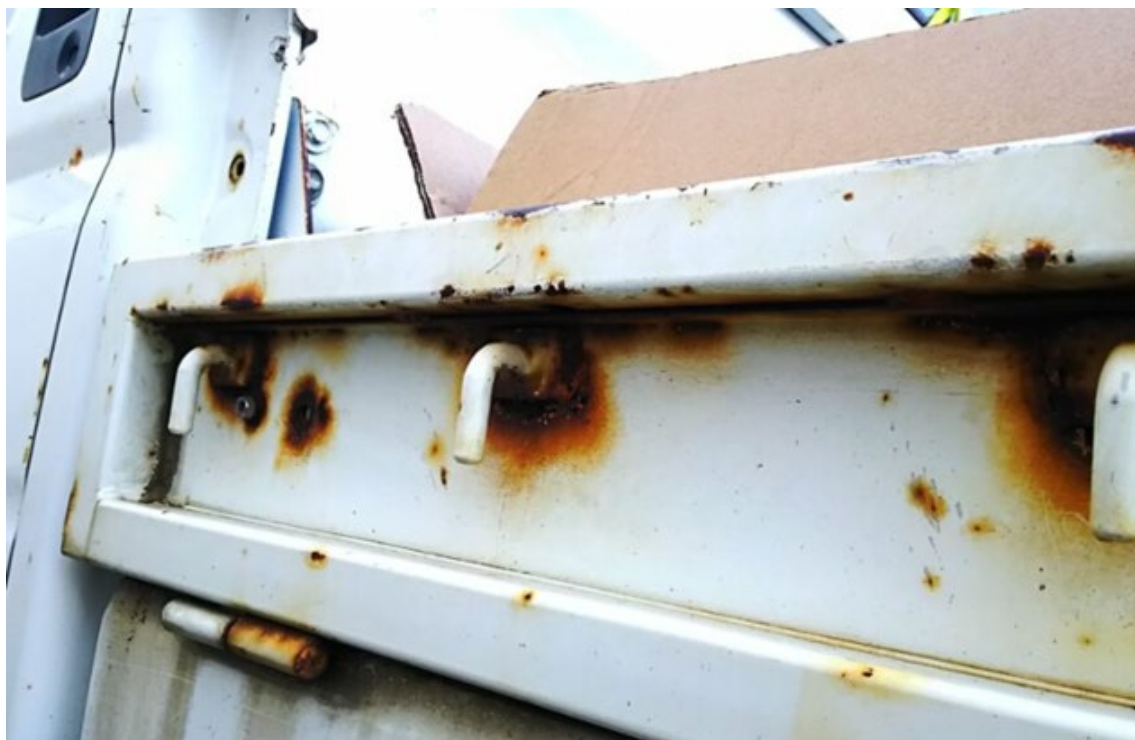
写真 22 Truck bed rusted/corroded トラック荷台の錆・腐食

- a: ボディに関しては錆止めのペイントを施す必要有り
- b: 荷台内底面と荷台内側面に関しては錆びていても可とする  
※平ボディ、ダンプの底面の穴は不可  
※写真 22 参照
